DELAWARE RIVER BASIN
BACK CREEK, MERCER COUNTY
NEW JERSEY

GROPPS LAKE DAM

NJ 00235

⑥ PHASE 1 INSPECTION REPORT
NATIONAL DAM SAFETY PROGRAM.

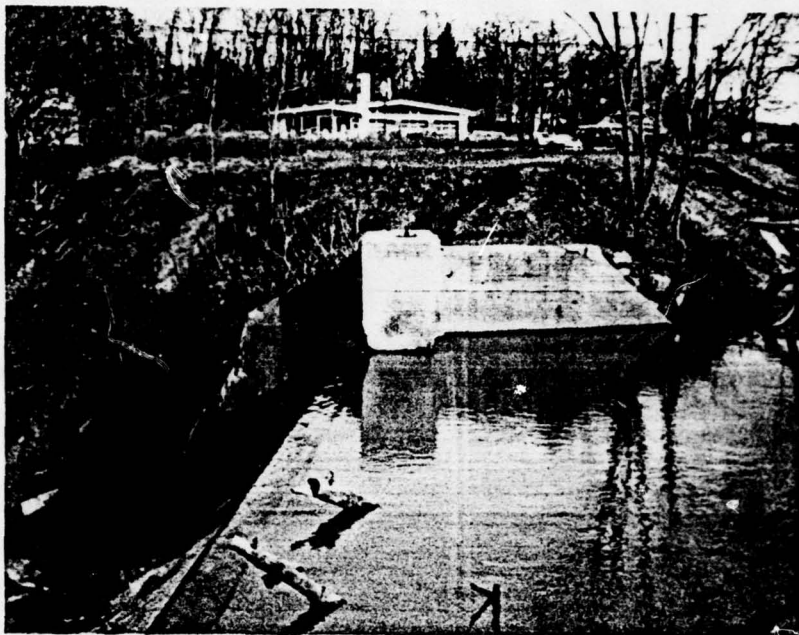
View of crest looking North East December, 1978

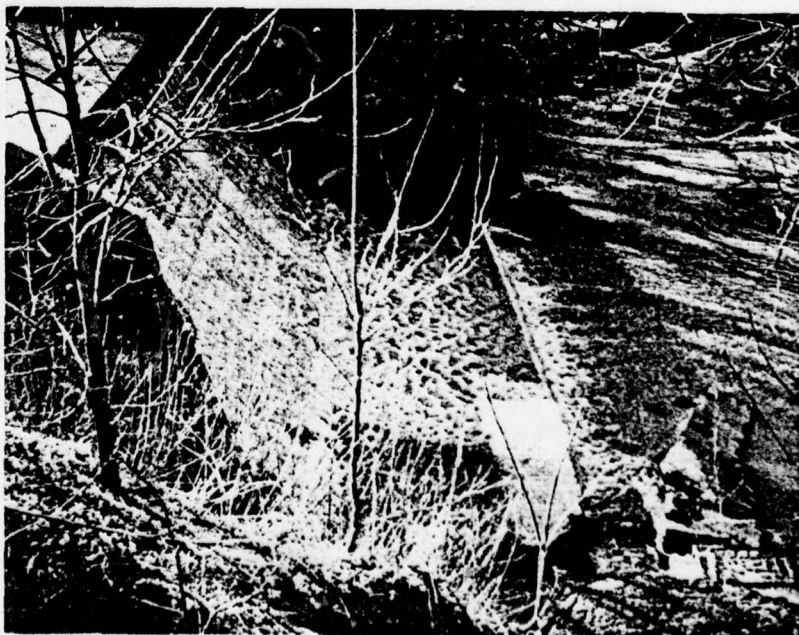
View of splash apron December, 1978

(1) The downstream edge of the splash apron should be protected (at least temporarily) by dumping riprap into the stilling basin.

(2) The undermined apron should be backfilled and/or pressure grouted.

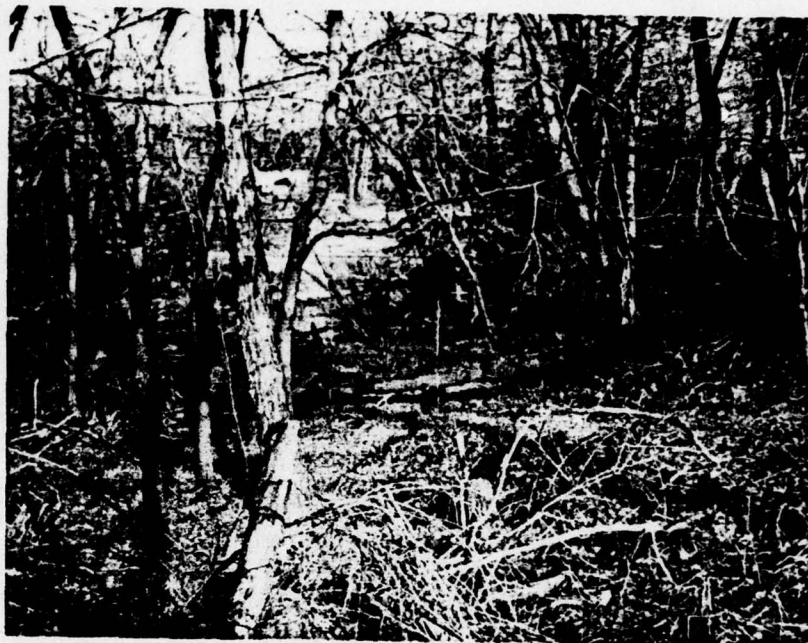
Downstream channel

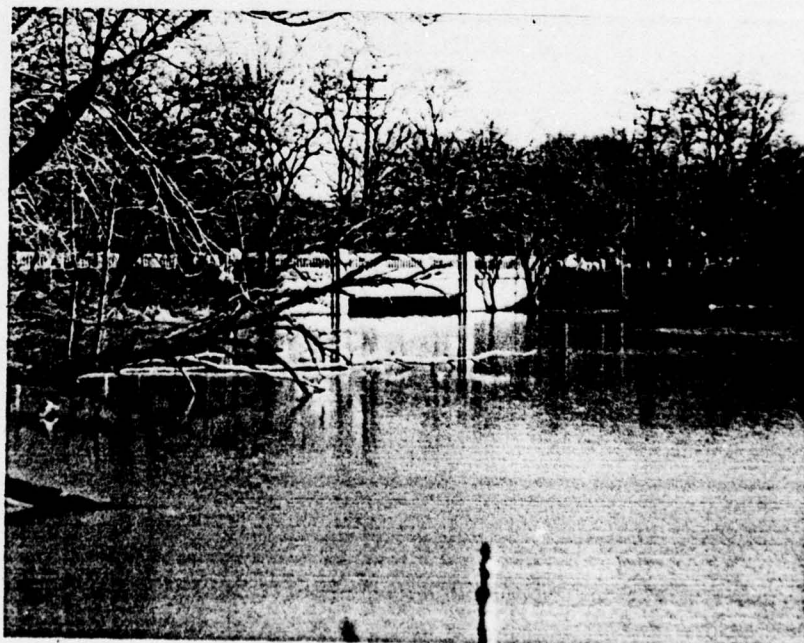
Bridge upstream from dam

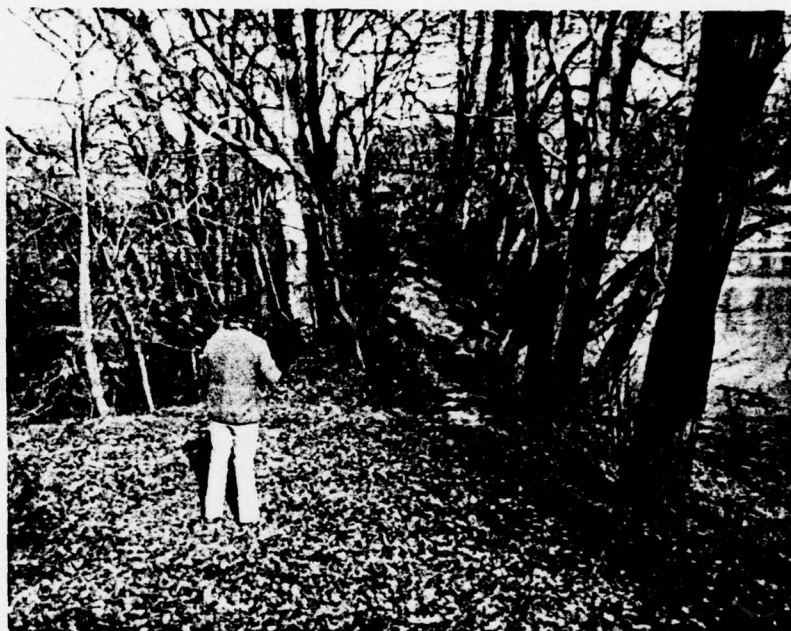
Crest of left embankment

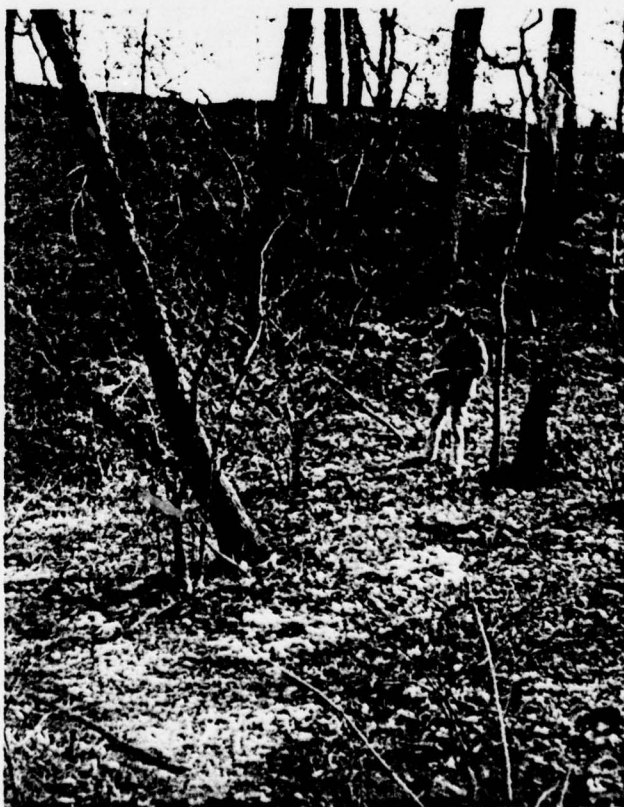
discolored by an orange silt, indicating a movement of fines from the soil. The back-slopes are in a more uniformly graded condition but are heavily wooded with several large stumps in evidence. Immediately below the left abutment, a drainage swale has eroded down the backslope due to surface run-off from the higher natural terrain to the south.

Seepage behind left embankment

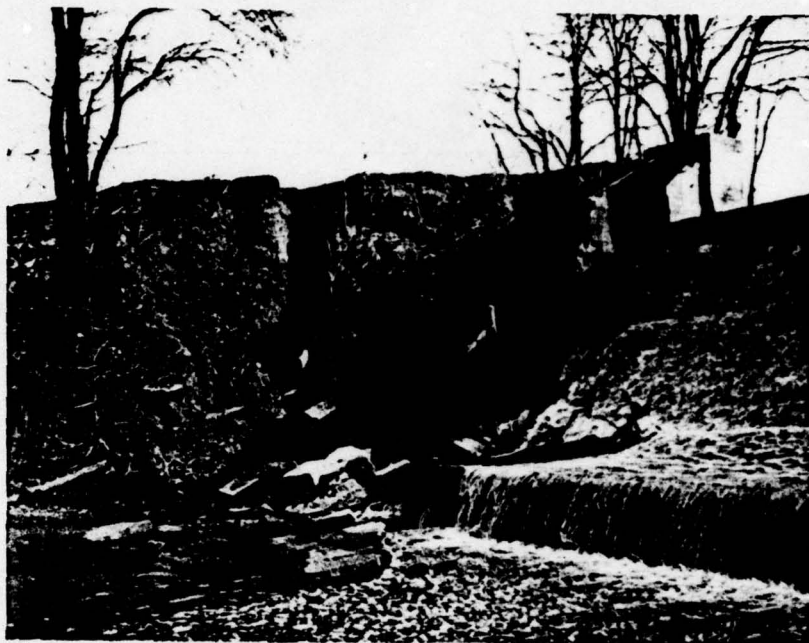
Cracks approximately 4' deep in right embankment. Sloughing behind right wingwall and right retaining wall.

Erosion of right embankment

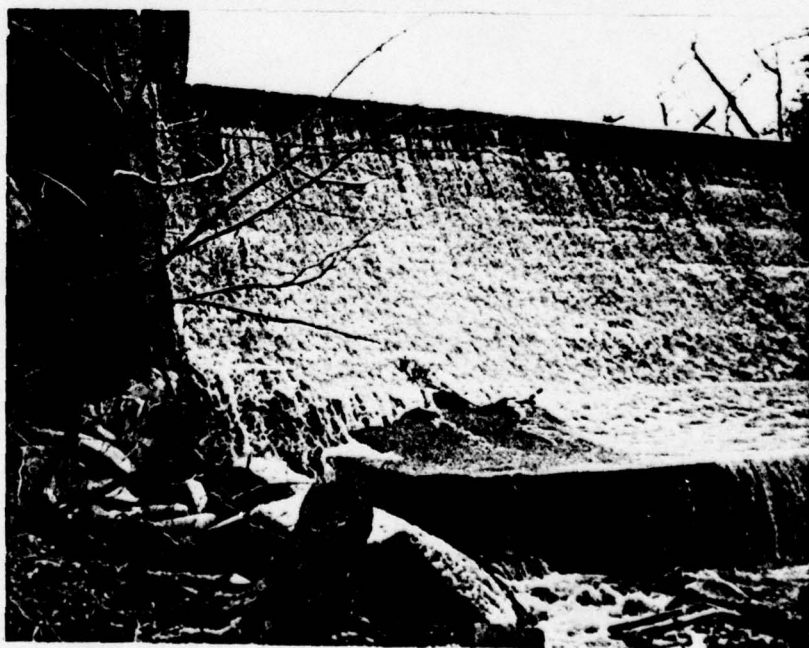
Undermining and separation of splash apron

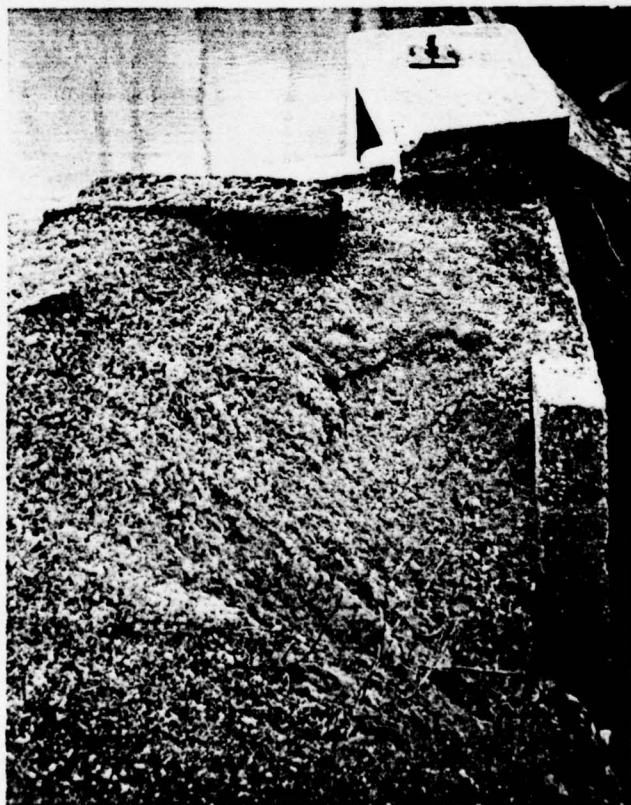
Sloughing and structural cracking at right wingwall

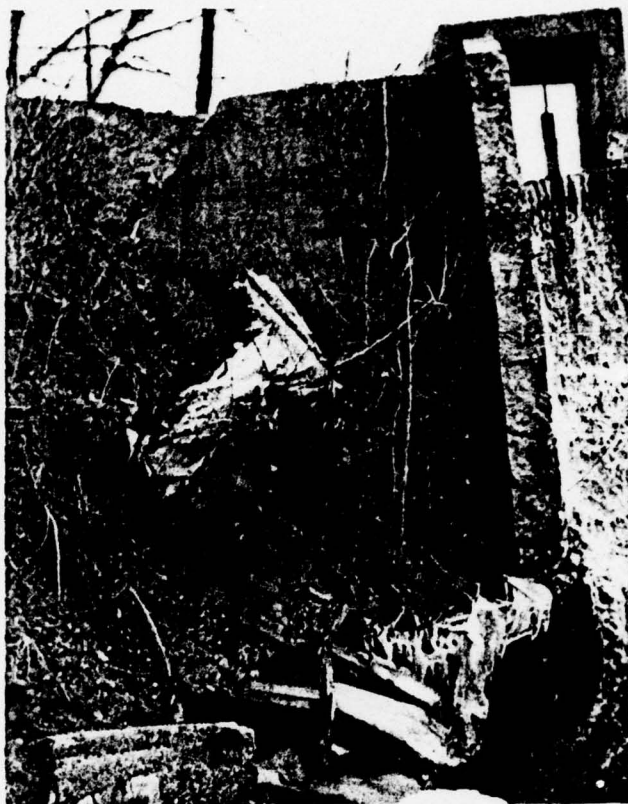
Deterioration of right wingwall structure

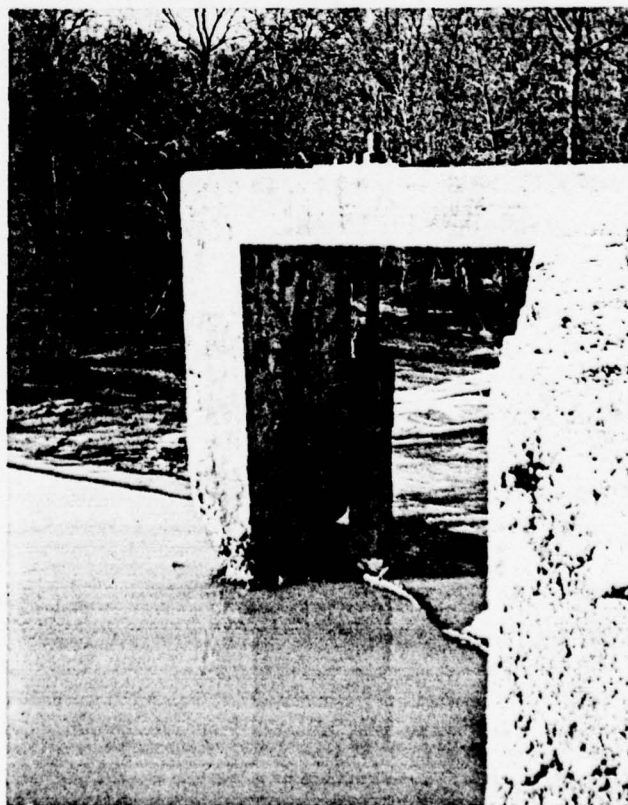
The only regulating component at the dam is the 36" diameter concrete sluice. Parts of the operating mechanism are missing and the concrete housing for the controls is in an advanced state of deterioration. No maintenance of this facility has been performed for a considerable period.

Deterioration of floodgate structure

(4) The sluice gate should be repaired and its entrance cleared of debris and silt.
